PRE-PURCHASE INSPECTION – RESIDENTIAL BUILDING REPORT

In accordance with AS. 4349.1 – 2007 Appendix C

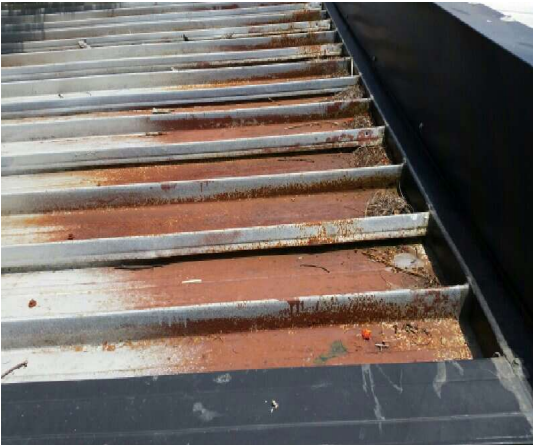
Roof- External:	Good	Fair	Repair	Description & Location of Defect	Significance & Recommended Action (Duty to Warn) (Also Refer to Important Advice)
Hips/Ridges/Pointing	==	==	==		
Valleys	==	==	==		
Main Body	✓				
Gutters & Down Pipes			✓	GUTTERS REQUIRE CLEAN OUT AND REFIXING.	
Fascias: Metal/Timber		✓		EVIDENCE OF MINOR DECAY/MOISTURE TO TIMBER FASCIA.	
Flashings	✓				
Skylights / Vents	==	==	==		
Chimney / Flues.	==	==	==		
(Note) All Valleys, Gutters & Flashings may leak in moderate to extreme weather conditions, Check & Maintain this areas, also concrete tiles may leak in time from non visible cracks & tile fixings.) Roofing (Metal Or Tiled) Any one with queries regarding the roof design and / or the integrity it is recommend a roof specialist be engaged. # Also see terms & condition number 23.					
Additional Structures:	Good	Fair	Repair		
Pergola		✓		MINOR SURFACE RUST TO UPPER PERGOLA ROOF. AND NO GUTTER TO LOWER PERGOLA/ PATIO.

MINOR SURFACE RUST TO PERGOLA ROOF.

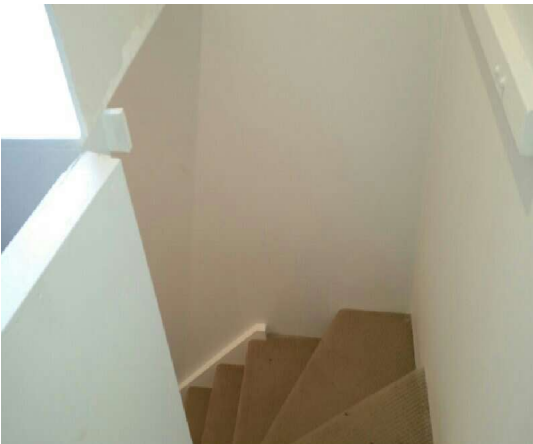
HEAD HEIGHT TO STAIRS DOES NOT COMPLY WITH CURRENT BUILDING CODES. ALSO NO HANDRAILS.

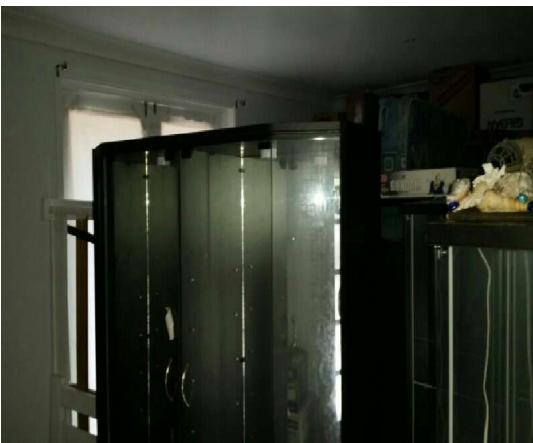
LIMITED ACCESS TO DOWN STAIRS BEDROOM 2.

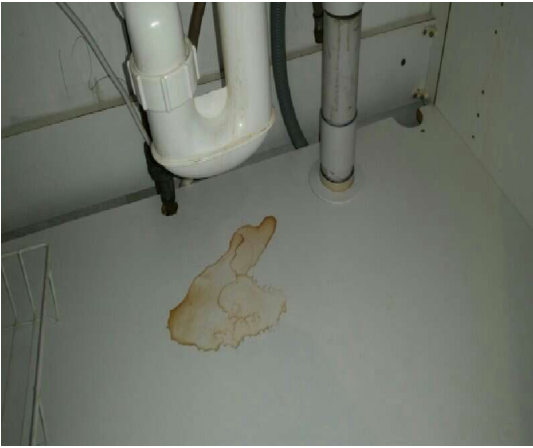
GAPS UNDER SINK NVP . AND MINOR PAST WATER MARK.

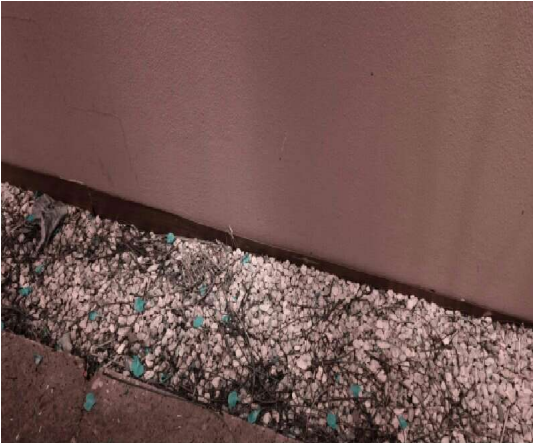
WATER FLOWING THROUGH BRICKWORK.

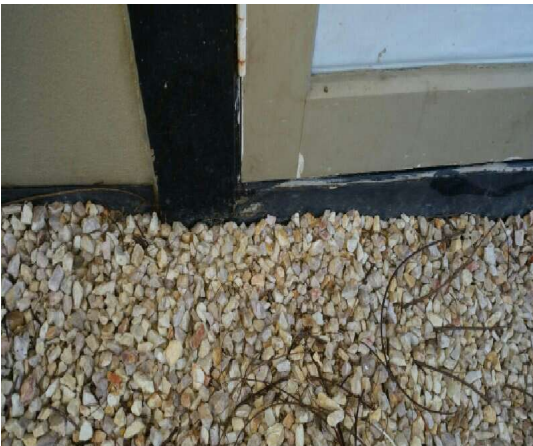
EVIDENCE OF MINOR DECAY TO TIMBER DOOR FRAME.

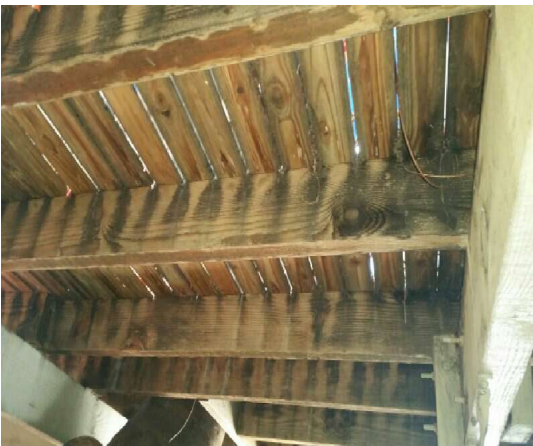
Sundries:	Good	Fair	Repair		
Patio/Verandah		✓		TIMBER POSTS IN CONTACT WITH GROUND.	
Decks/Balconies/Rails		✓		EVIDENCE OF MINOR DECAY TO EXPOSED TIMBERS TO DECKS. TIMBER POSTS INCONTACT WITH GROUND.	Concrete decks/balconies should have sealant to edges & penetrations checked & maintained to prevent leaks to concrete balconies & decay to non-visible timbers, Timber decks should be inspected regularly.
Stairs – External			✓	EVIDENCE OF DECAY TO TIMBER TREADS & RUST TO SUPPORT STEEL FRAMES.	This does not cover landscaping or garden stairs.
Meter Board/ Electrical Installation	✓			Electrical Safety Switch IS installed as per government requirement. * Its recommended that a licensed electrician be consulted for further advice.	
Plumbing	==	==	==	* Its recommended that a licensed plumber be consulted for further advice.	
Smoke Detectors.	✓			Installed : YES AS 3786 – Advises that smoke detectors are required for all buildings where people sleep. It is recommended that an electrician be consulted to advise on those installed or to install these detectors. No test of smoke alarm device conducted. Note: Mandatory as at 1 July 2007

EVIDENCE OF MINOR DECAY TO EXPOSED TIMBERS TO REAR DECK.

- (4). **Decks and Balconies:** Exposed timber decks will decay if timber is left untreated. Treat all exposed timbers – 50% raw linseed oil + 50% turps. Tops of open decks, floor joists and tops of open pergolas – moisture will cause timber to decay (dry & wet rot). Tiled or concrete decks/balconies should have sealant to edges & penetrations checked & maintained to prevent leaks to concrete balconies & decay to non-visible timbers, and should be inspected regular.

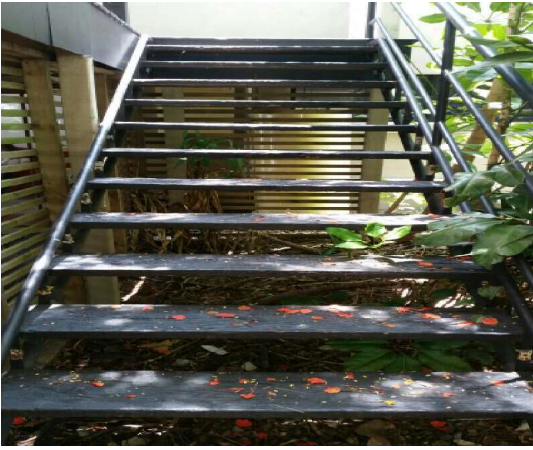
EVIDENCE OF DECAY TO TIMBER TREADS & RUST TO SUPPORT STEEL FRAME.

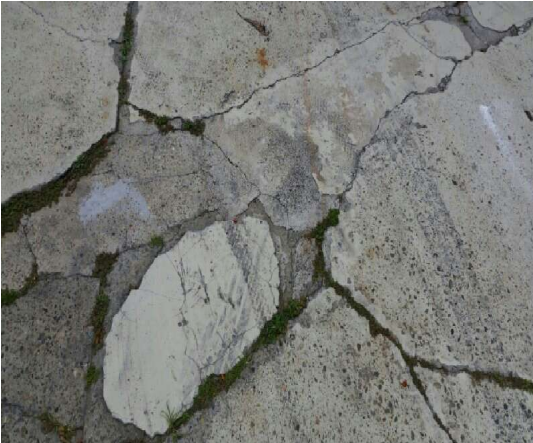
Areas Inspected	Location	Significance of the Defect. Recommended Action. (Duty to Warn) (Also refer to Important Advice Section)
7.01 Concrete Slabs		
7.02 Suspended Concrete Slabs		
7.03 Masonry Walls	EVIDENCE OF MINOR CRACKS TO BRICK RENDER WALL UNDER WINDOW TO LEFT SIDE OF PROPERTY.	APPEARANCE DEFECT
7.04 Piers		
7.05 Retaining Walls		
7.06 Timber Building Elements		
7.07 Paths	EVIDENCE OF MAJOR CRACKS & MOVEMENT TO CONCRETE DRIVEWAY AND PATHS.	APPEARANCE DEFECT
7.08 Other Areas

MAJOR CRACKS & MOVEMENT TO CONCRETE DRIVEWAY AND PATHS.

- (14). **Cracks &/ or Movement:** To concrete slab and or brickwork may indicate movement or subsidence to the earth/ ground or fill under or around foundation – recommend checking with local authority for any record or knowledge of similar land problems. Or engage an engineer to carry out an inspection on the property.

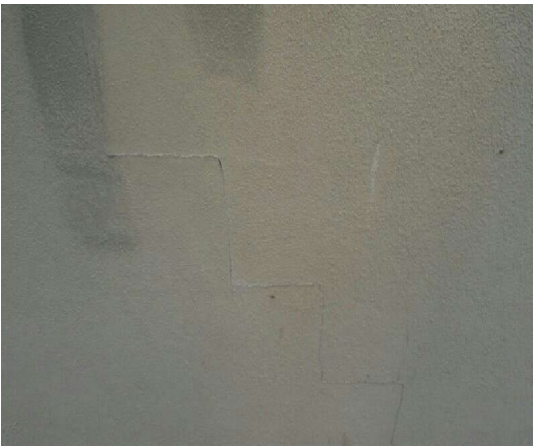
MINOR CRACK IN BRICK RENDER FINISH UNDER WINDOW TO LEFT SIDE.

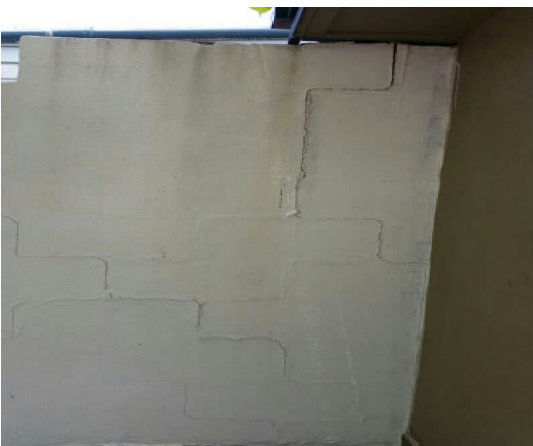
EVIDENCE OF MINOR CRACKS TO CONCRETE BLOCK FENCES.

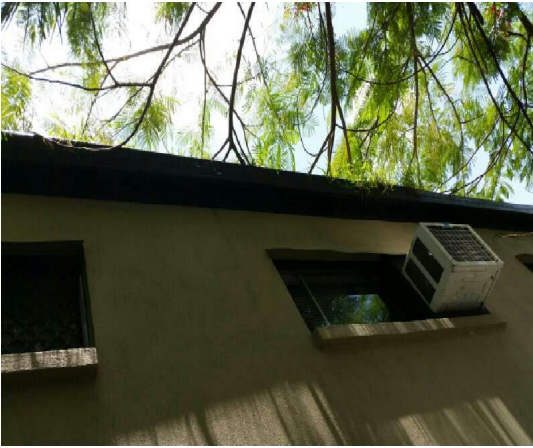
SIDE GUTTER FULL OF LEVES & RUBBISH CAUSING GUTTERS TO OVERFLOW.

- (1). **Fascia & Soffits:** Check and clear roof and gutters and silicone joins. If not regularly cleaned timber rot and water damage can occur to fascia and soffits.

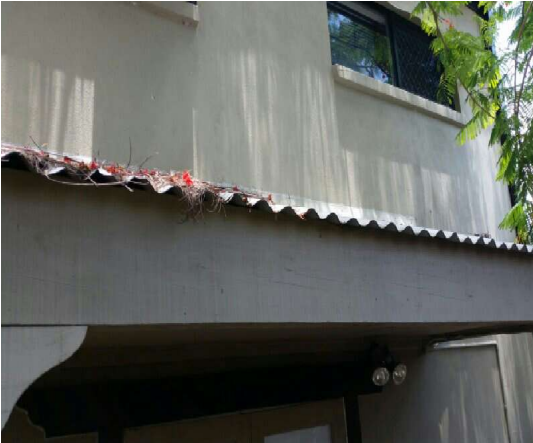
NO GUTTER TO SIDE PERGOLA / PATIO.
