PRE-PURCHASE VISUAL TIMBER PEST REPORT

Report number:
Inspection date:
Property address:

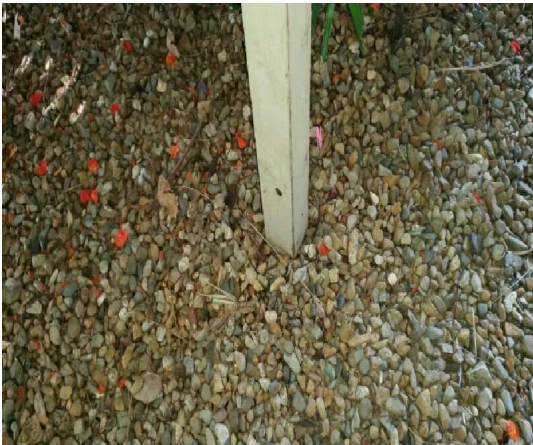
Not applicable due to construction design. TIMBER POSTS IN CONTACT WITH GROUND AND MOISTURE TO LEFT SIDE WALL , IMPROVE SURFACE WATER DRAINAGE TO PREVENT WATER FLOWING TOWARDS HOUSE.

POSTS INCONTACT WITH GROUND.

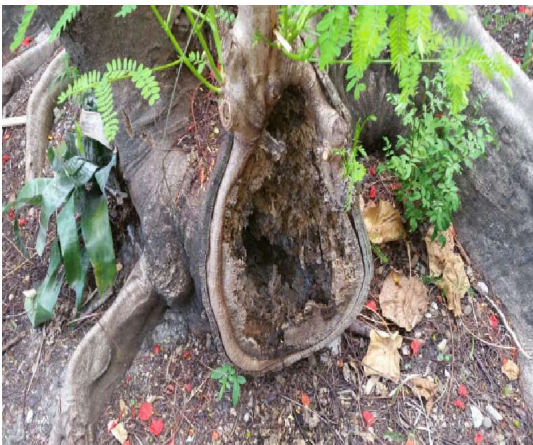
While we are not builders, the termite damage appears to be: Moderate to extensive.

Termite workings and damage was located but not limited to: IN TREE STUMP IN LEFT SIDE GARDEN.

EVIDENCE OF PAST TERMITE MUDDING / NEST IN TREE STUMP TO LEFT SIDE GARDEN.

Although a subterranean termite management proposal is recommended, this Consultant is not engaged to provide a proposal. Accordingly, the Client should contact the consultant or other licensed pest control operators in respect to obtaining a proposal.

A proposal in accordance with Australian Standard AS 3660.2 to treat a known infestation and/or help manage the risk of concealed subterranean termite access to buildings and structures is recommended. Ie; Installation of termite baits or chemical termite protection and regular inspections.
